DE HAAN (BELGIUM)

**HAECON -Harbour and Engineering
Consultants**

1. GENERAL DESCRIPTION OF THE AREA

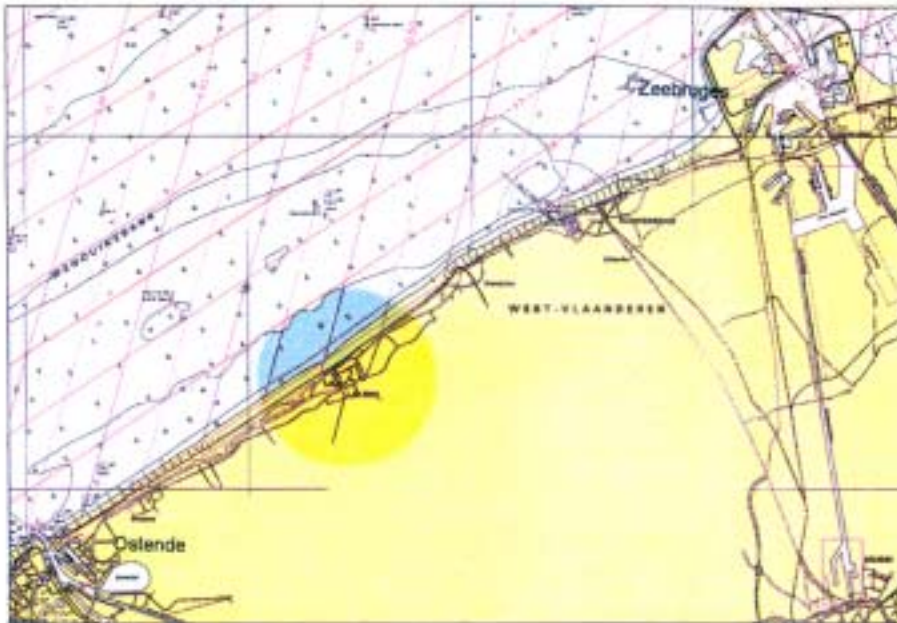
Fig. 3: Case area De Haan.

As was described before severe erosion occurs due to storm surges at De Haan. Unlike other parts of the Belgian coast, at De Haan very limited protection from wave attack is provided by shallow coastal sandbanks. A study showed that the major coast erosion mechanism at De Haan is caused by intense cross-shore redistribution of sand in a ridge and runnel beach system. During storms, the sand accumulates in the LW-bar; during calmer weather periods, the sand is remobilised and transported in the onshore direction.

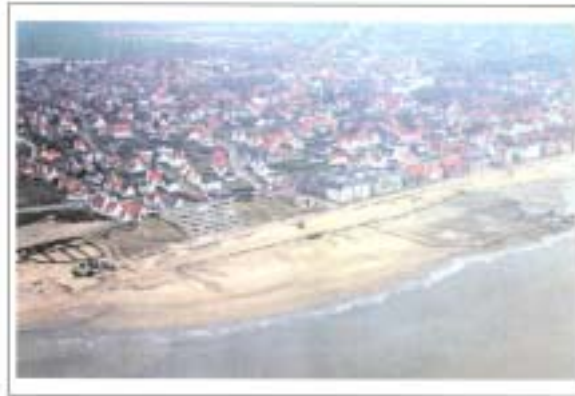
Fig. 4: Site De Haan during performing of works.

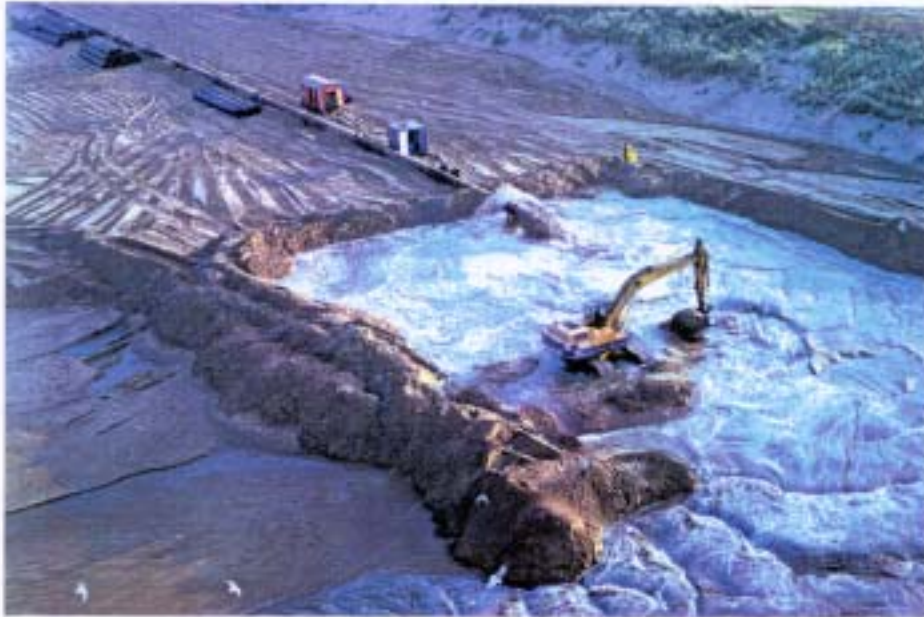
Fig. 6: Profile nourishment at De Haan.

The longshore feeder berm has a length of about 2,200 m and is located at 600 m from the shoreline on the seaside of the low water bar. About 600,000 m³ of sand was dumped at the proper site with a split hopper dredger. For the profile nourishment 800,000 m³ of sand was pumped onshore through a sunken line of approximately 1500 m long. The works were carried out with self-unloading trailer suction hopper dredgers, discharge pipe + booster station and bulldozers.

Sloped beach replenishment (between H + 7,5 m and H 0 m) with a 40 m bench at H + 7,5 m (beach).

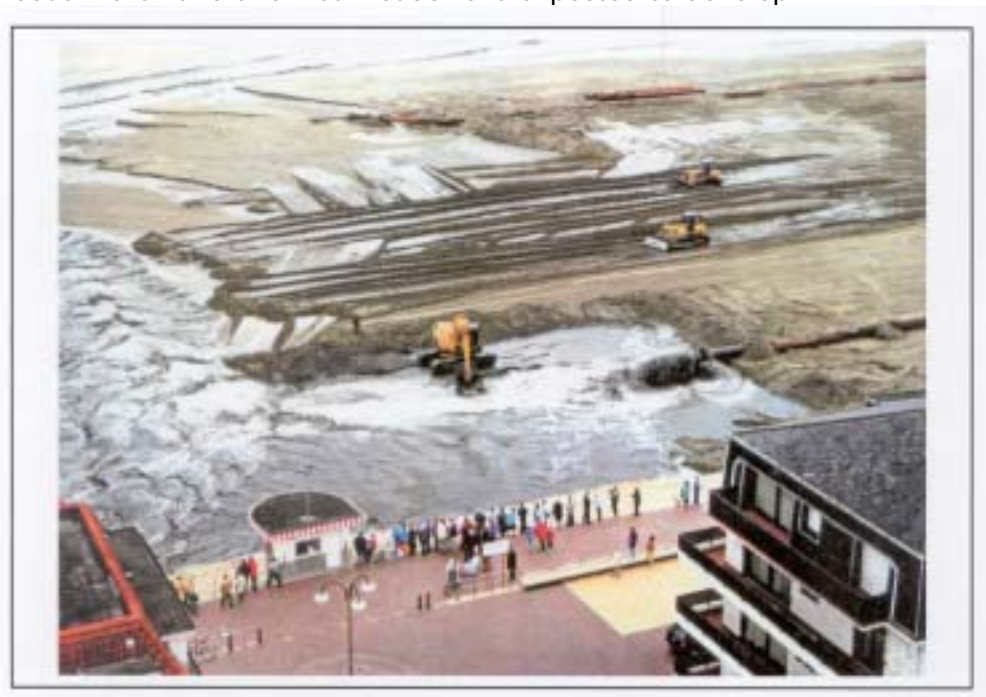
Fig. 7: Beach profiling works at De Haan.
